**CASCADE - WARM LAKE**  
**Terracon Project No. 62005055A**  
**PHOTO LOG**

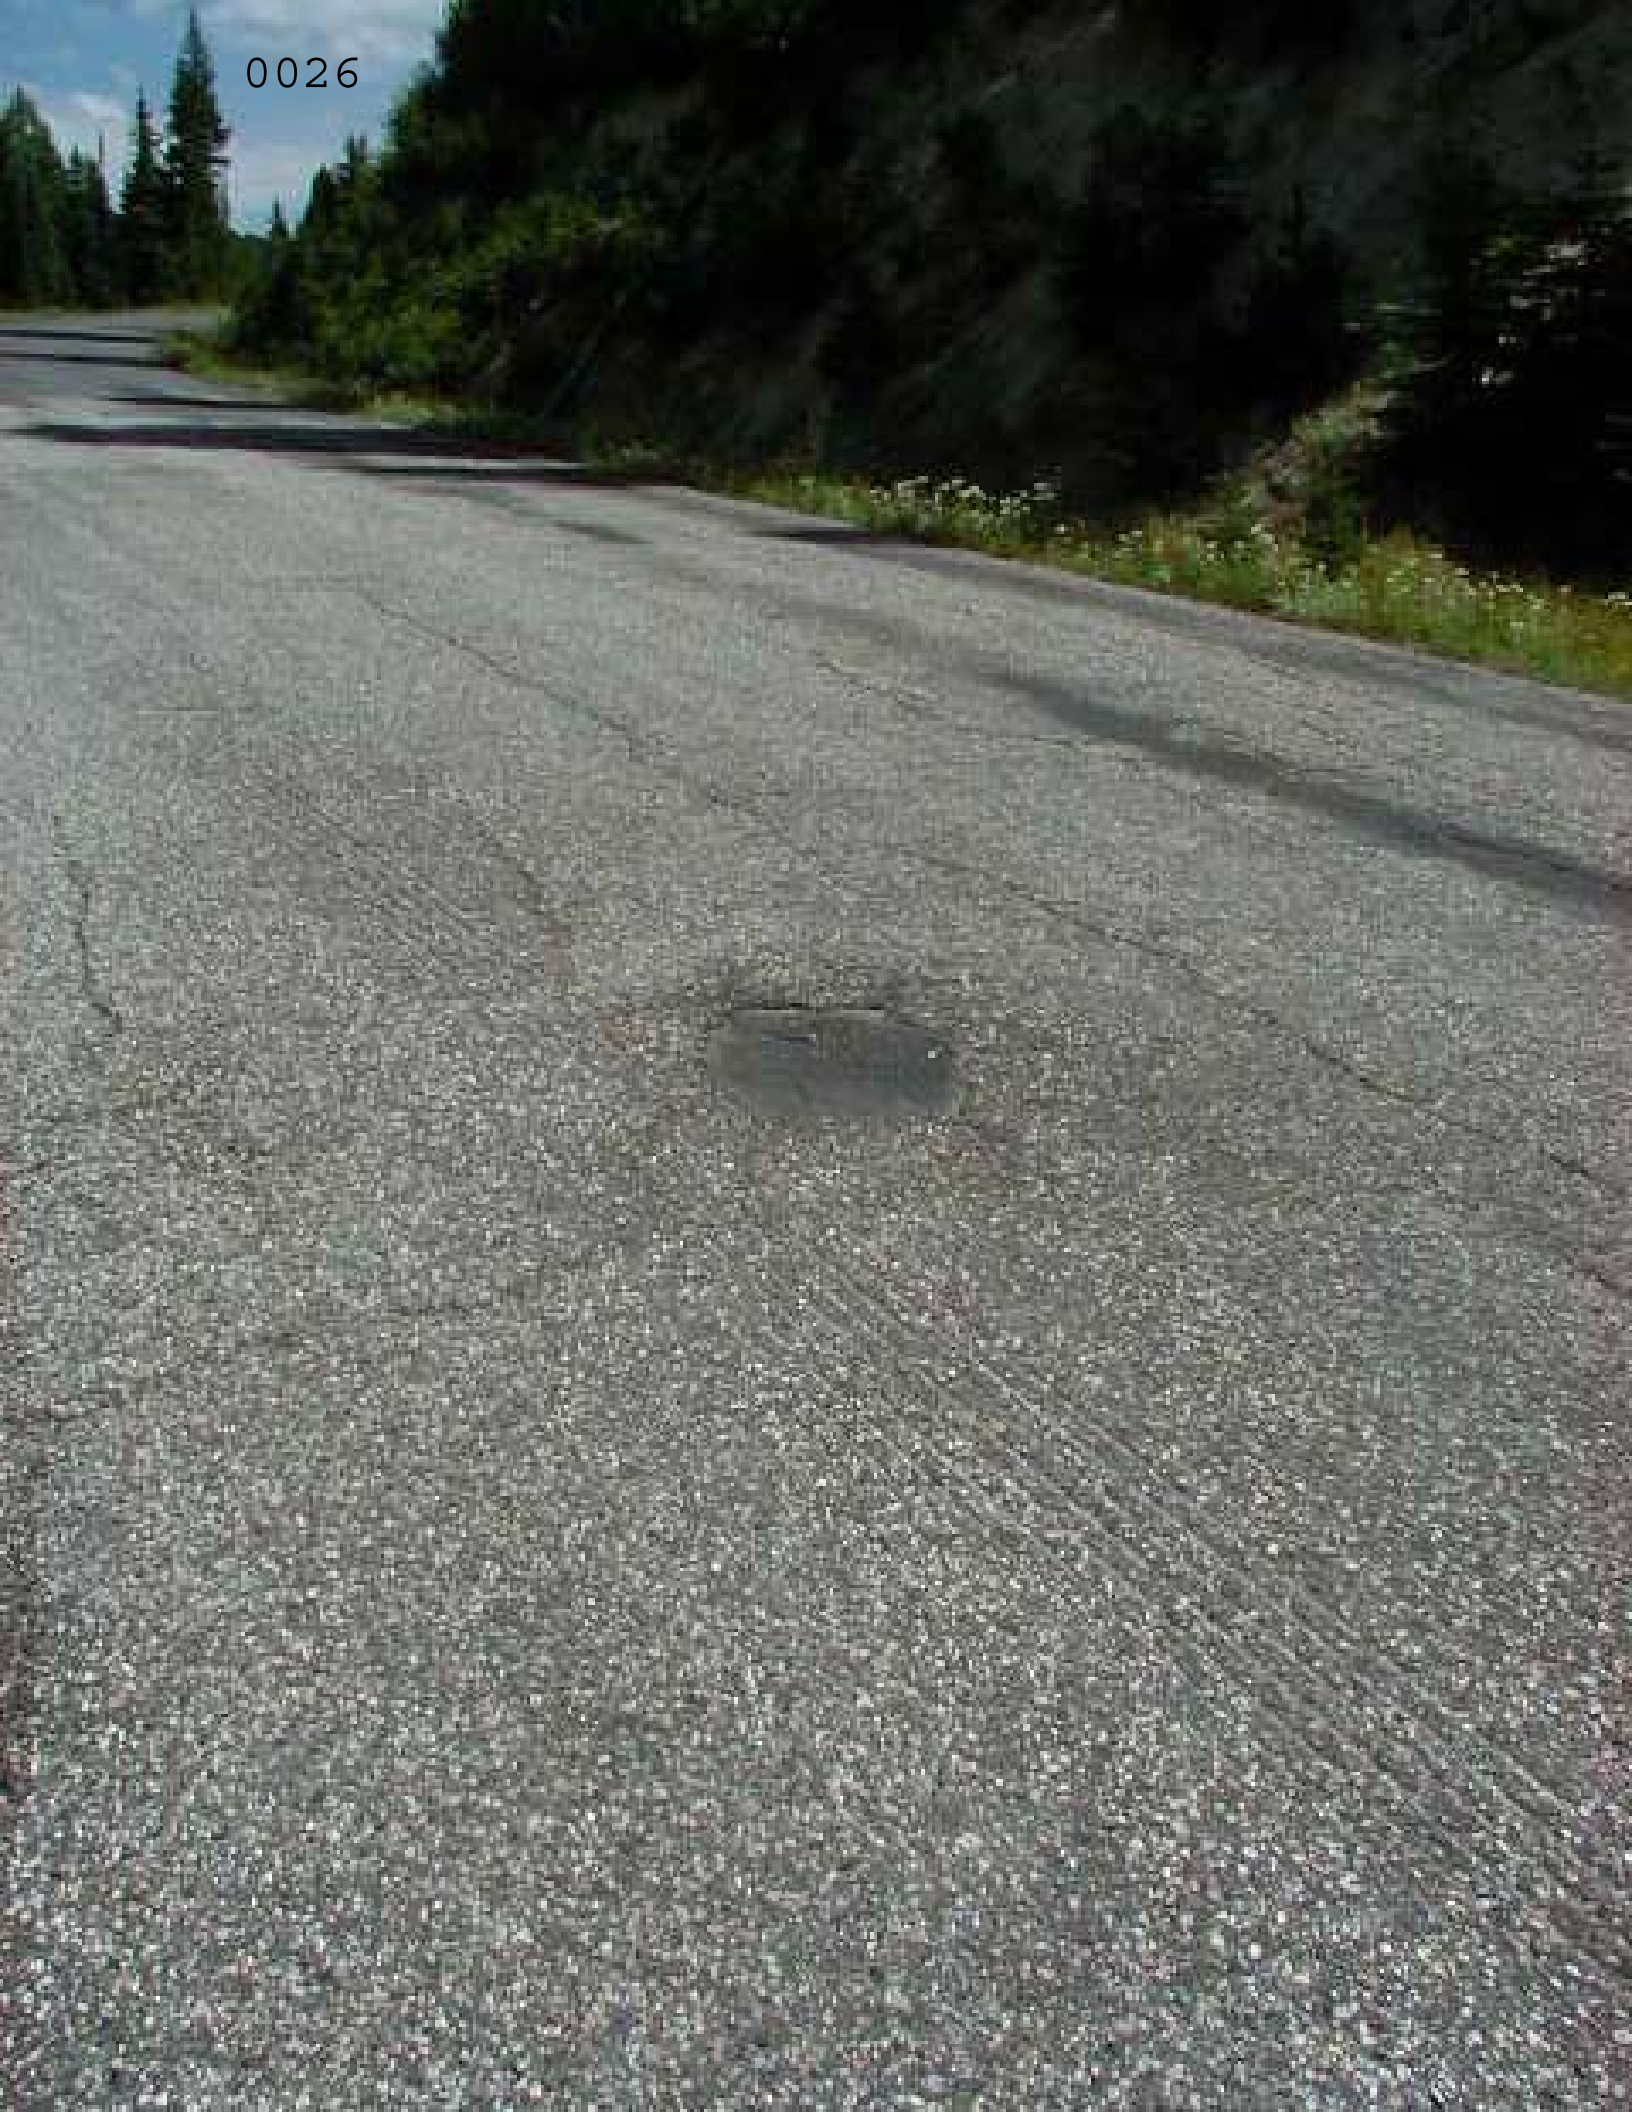
0026	14.2	FH-11; Loss of aggregate, cracking, snowplow grooves
0027	14.5	FH-12; EB view
0028	14.5	FH-12; Transverse crack, snowplow grooves
0029	15	FH-13; WB lane, snowplow grooves, patch at cut (EB)
0030	15	FH-13; EB lane patch at cut
0031 0032	15.3	Cut section, snowplow grooves, minor ravelling
0033	16.1	FH-14; Core 14, EB view
0024	16.1	Below summit; near FH-14
0025	16.1	FH-14; (WB view)
0036	17.1	Core 15; cut in granite
0037	17.9	FH-16; Rutting near west end (Fill area)
0038	17.9	FH-16; West end of cut
0039	17.9	FH-16; Ravelling, transverse and longitudinal cracks
0040	17.9	FH-16; WB view near east end of cut
0041	18.5	Steep cut in granite; up to 1-inch cracks in EB lane
0042	18.5	Cracks in outside wheelpath and rutting (EB)
0043	18.9	FH-18; Heave in WB lane
0044	19.5	Change in section near entrance to Clear Creek Road (EB view)
0045	20.3	FH-19; WB view
0046	20.3	FH-19; WB lane, cracking, ravelling, rutting

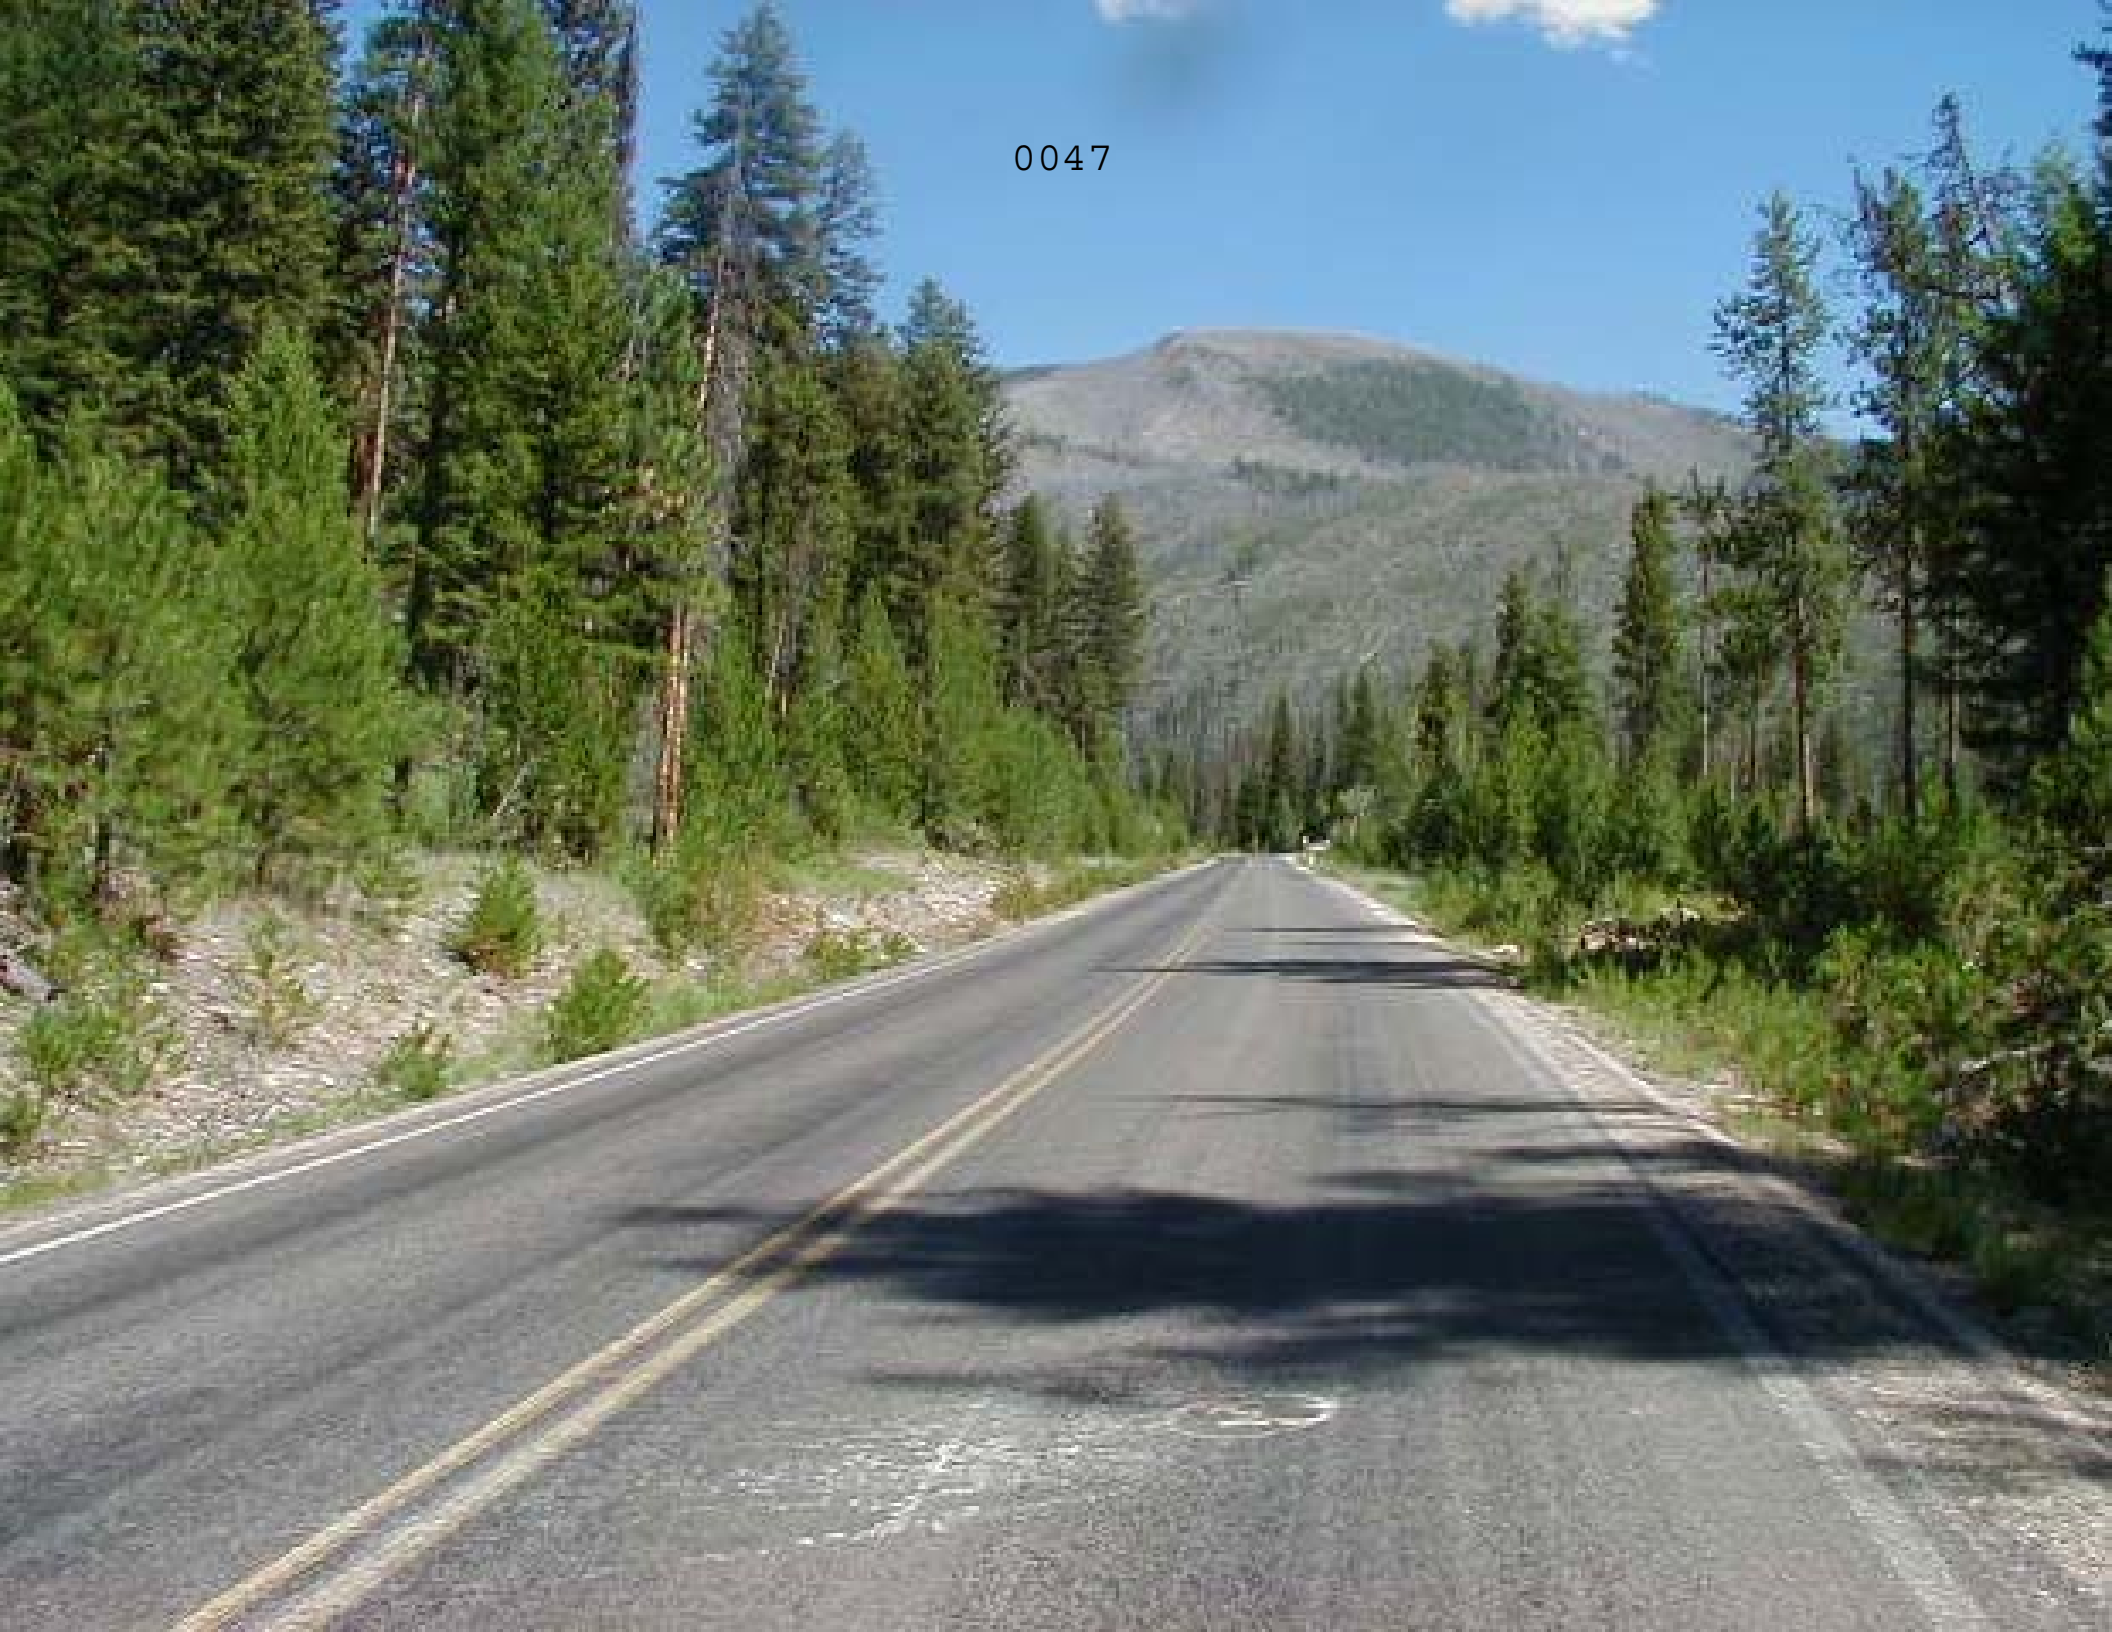
0047	26.2	Bleeding chip seal
0048	27.5	Bleeding chip seal near Firefighter Memorial Trail
0049	N/R	Warm Lake
0050	21.7	FH-20; patched, rutted, cracked, EB lane
0051	N/R	WB view of bleeding surface (west of beginning of project)
